## Inadequate Work Package Results in Water Hammer in Steam System

# OPERATING EXPERIENCE SUMMARY

Issue Number 2006-11, Article 1: Inadequate Work Package Results in Water Hammer in Steam System

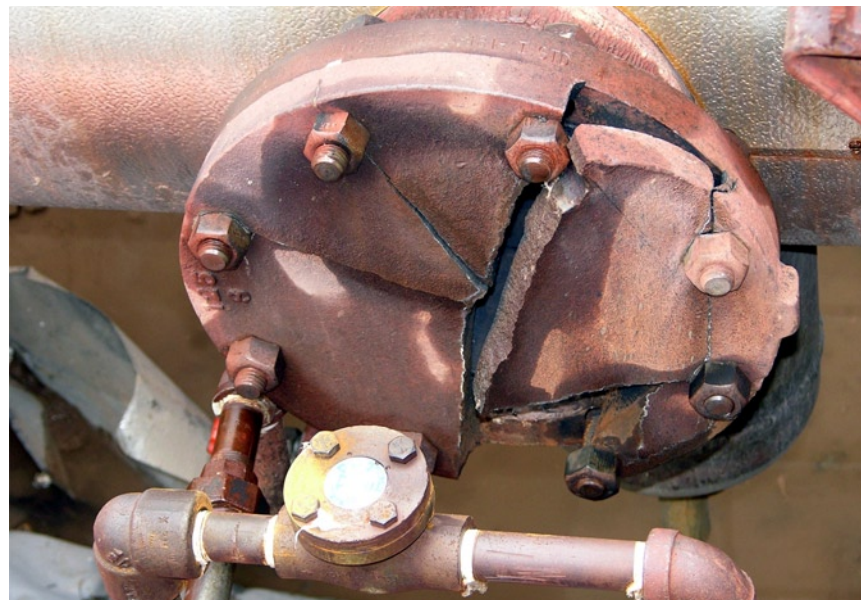
Figure 1-1. Failed blind flange

in other manholes. Steam plant recorders indicated that the duration of the steam release was approximately 5 minutes. The damaged blind flange and ruptured expansion joint are shown in Figures 1-1 and 1-2. Water (condensate) had accumulated in the steam piping upstream of the isolation valve; when the valve was opened, the condensate flashed, causing extremely high-pressure pulses in the steam piping.

A contributing factor was that the 1950s-era flange that failed was made of cast iron with a maximum pressure failure rating of 125 psi. LANL engineering standards require all steam system flanges to be steel with a maximum failure pressure of 150 psi. As a corrective action, LANL Utilities personnel are conducting a system-wide survey to identify and replace all nonconforming flanges.

Investigators determined that the work package preparation was inadequate. The Integrated Work Document and Work Order were valid, but the procedure used to perform the work was a general “Steam Startup” procedure, which was not specifically tailored to the job the pipefitters performed. If the pipefitters had used a specific procedure, the condensate collected upstream of the isolation valve would have been drained off, and the water hammer would have been prevented.
